# starlog

A SERIES OF FLOORCOVERING BULLETINS

## COMING UNGLUED

### BOND FAILURE SYMPTOMS AND SOLUTIONS

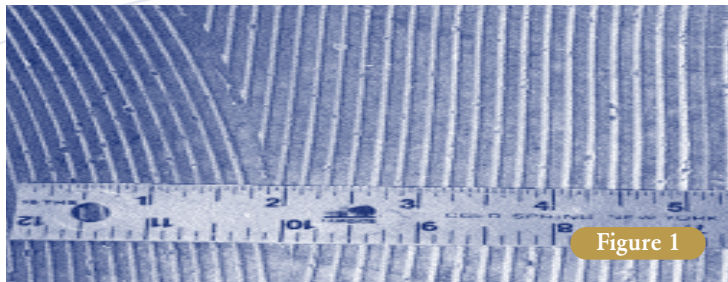
Figure 1

**TROWEL PROBLEMS:** Trowel notches that are too small (Figure 1) result in poor adhesive transfer. (Figure 2) Trowels that are too badly worn (Figure 3) also apply too little adhesive seen in (Figure 4). (Figure 5) shows progressive trowel wear. Note the difference in adhesive transfer: The right half of the corridor was spread with a trowel that was slightly worn; by the time the left half was spread, the trowel was severely worn.

By far the leading cause of bond failure in both direct-glue and double-glue installations is application of too little adhesive, usually resulting from use of a trowel that is the wrong size (Figures 1 and 2, following page) and/or too worn (Figures 3, 4 and 5) to provide 100% transfer of adhesive to the carpet.

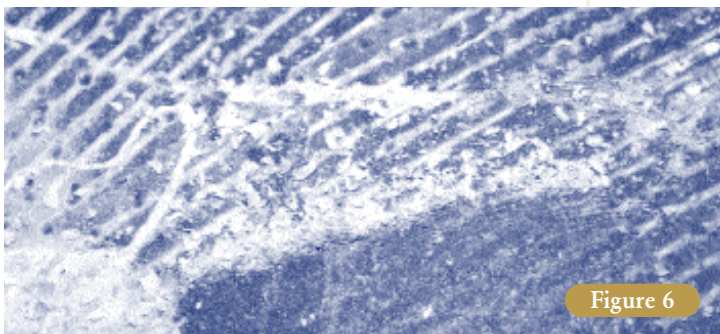
Figure 6

Prolonged exposure to moisture and/or high alkalinity is detrimental to most adhesives. (Figures 6 and 7). Unfortunately the pH of moisture released by concrete often is as high as 12 to 12.5, more than 1,000 times higher than most adhesives can withstand. Alkali from within concrete is carried to the surface by migration of water from under or within the slab toward warmer, drier air at the surface. Depending on the porosity of the carpet, moisture emissions generally should be below 3-5 pounds per 1000 square feet per 24 hours as measured by the quantitative calcium chloride test.

6.2 Moisture and Alkalinity in Concrete Subfloors - To prevent glue-down installation failures due to moisture and alkalinity, the owner or general contractor shall be responsible for providing written moisture and alkali test results pertaining to the concrete slab prior to installation.

6.2.2 Alkalinity - A pH range of 5-9 is satisfactory; however, a reading above 9 requires corrective measures. Consult the adhesive manufacturer for recommended corrective procedures.

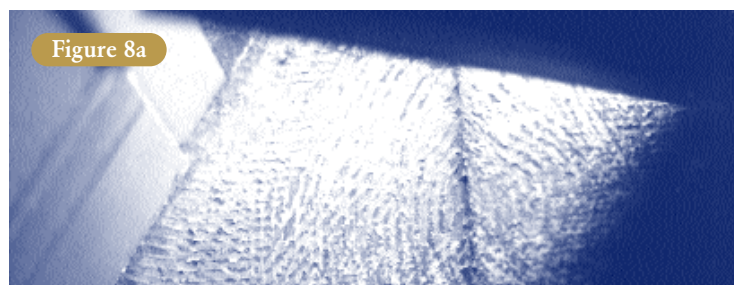
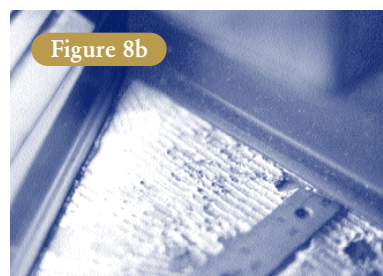
**INVESTIGATION:**  
A clear picture of the job's installation and repair history. Ultraviolet light often reveals features of adhesive application and transfer that cannot be seen under visible light.

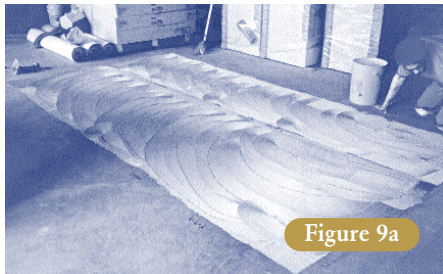
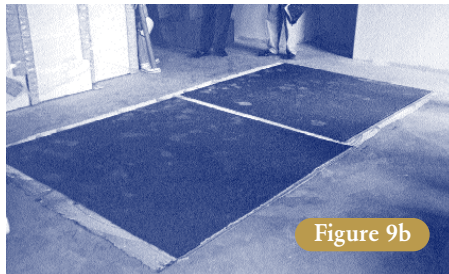
Because numerous variables are involved, correctly diagnosing the cause of bond failure can be complex. In the illustrations below, pre-installation bond tests (Figures 9a and 9b) were conducted to assess the suitability of the slab to receive carpet. Fortunately, the tests identified a bonding problem before installation began. (Figure 10) Additional tests confirmed that an extremely strong bond could be achieved with additional floor preparation. (Figure 11)
