starlog

A SERIES OF FLOORCOVERING BULLETINS

COMING UNGLUED

BOND FAILURE SYMPTOMS AND SOLUTIONS

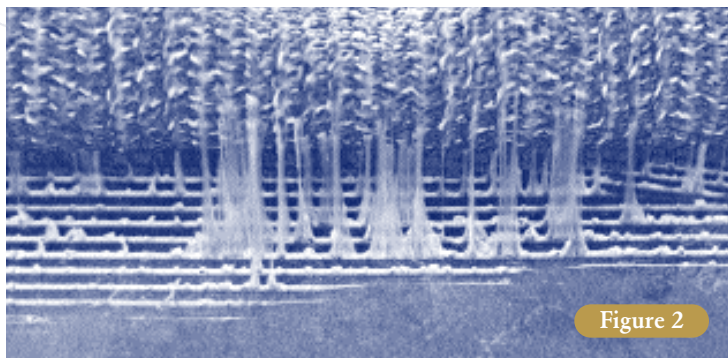
TROWEL PROBLEMS: Trowel notches that are too small (Figure 1) result in poor adhesive transfer. (Figure 2) Trowels that are too badly worn (Figure 3) also apply too little adhesive seen in (Figure 4). (Figure 5) shows progressive trowel wear. Note the difference in adhesive transfer: The right half of the corridor was spread with a trowel that was slightly worn; by the time the left half was spread, the trowel was severely worn.

By far the leading cause of bond failure in both direct-glue and double-glue installations is application of too little adhesive, usually resulting from use of a trowel that is the wrong size (Figures 1 and 2, following page) and/or too worn (Figures 3, 4 and 5) to provide 100% transfer of adhesive to the carpet.

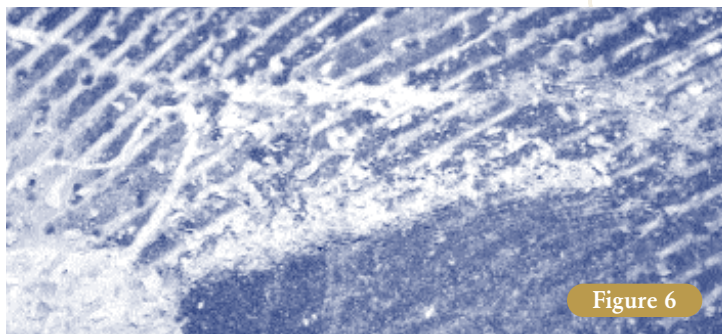
Figure 7

Prolonged exposure to moisture and/or high alkalinity is detrimental to most adhesives. (Figures 6 and 7). Unfortunately the pH of moisture released by concrete often is as high as 12 to 12.5, more than 1,000 times higher than most adhesives can withstand. Alkali from within concrete is carried to the surface by migration of water from under or within the slab toward warmer, drier air at the surface. Depending on the porosity of the carpet, moisture emissions generally should be below 3-5 pounds per 1000 square feet per 24 hours as measured by the quantitative calcium chloride test.

6.2 Moisture and Alkalinity in Concrete Subfloors - To prevent glue-down installation failures due to moisture and alkalinity, the owner or general contractor shall be responsible for providing written moisture and alkali test results pertaining to the concrete slab prior to installation.

As a general guideline, an emission rate of 3 lbs. or less is acceptable for most carpet. In the range from 3 to 5 lbs., carpet with backings of porous construction can usually be installed successfully. An emission rate above 5 lbs. is considered unacceptable.

6.2.2 Alkalinity - A pH range of 5-9 is satisfactory; however, a reading above 9 requires corrective measures. Consult the adhesive manufacturer for recommended corrective procedures.
